**THE CALIFORNIA EARTHQUAKE OF APRIL 18, 1906**

**REPORT**

**OF THE**

ANDREW C. LAWSON

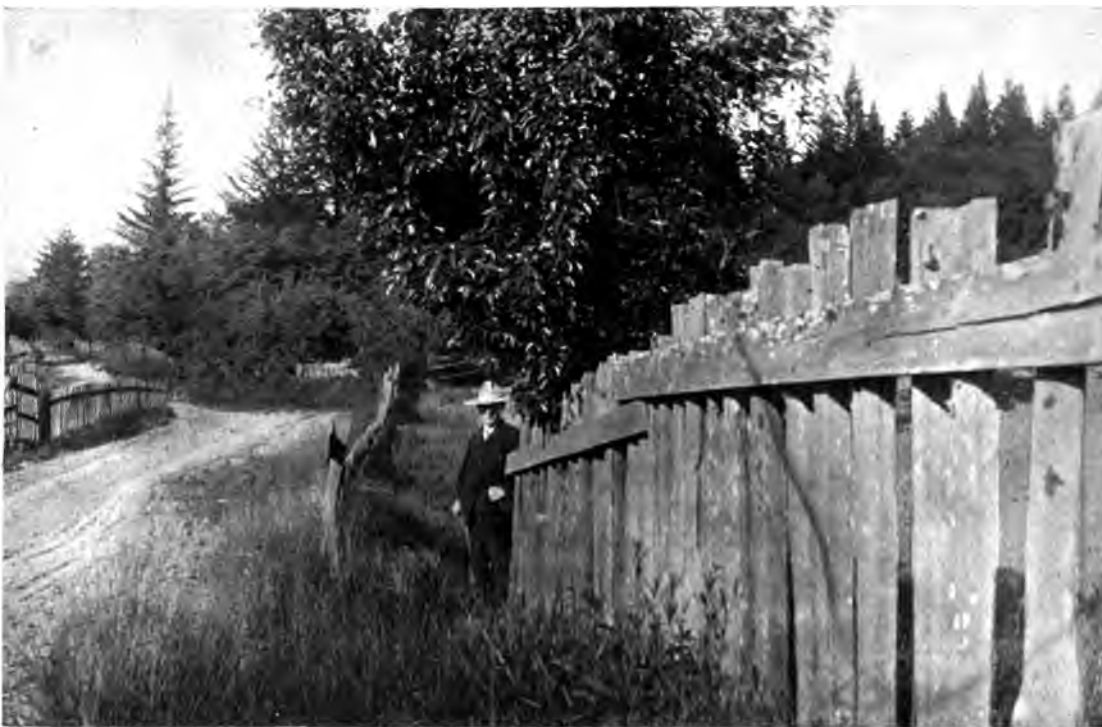
cracks alternating with a few long, continuous fissures, mark the course from Patchin to Wright Station. Thru the Morrell ranch it is especially evident. (See plate 64B.) At Wright Station the movement is well shown in the railway tunnel. (Fig. 42.) This tunnel runs southwest, and about 400 feet in from the eastern end of it there is a nearly vertical slicken-sided plane, showing a shear movement of 5 feet. Apparently the southwest side moved northwestward. Between Wright and Alma, the railway track was badly bent in places (see plate 107A), but the ground did not crack noticeably. It seems to have been subjected to compression, for 7 inches had to be cut from the rails when the track was repaired. A large landslide also occurred close to Wright Station, partly damming up the stream. The fault past a little west of Wright, tearing up the public road at several places (plate 65A), especially at the blacksmith shop, near Burrell Schoolhouse. Sulfurous fumes are said to have risen from this crack for several hours. From this place the cracks run up over the ridge just west of Skyland. Large fissures show in the orchards and fields on the eastern side of the ridge, but are not so evident on the western slope. Here, instead, great landslides occurred, and redwoods were snapt off or uprooted. Thru the timbered region from Skyland to Aptos Creek, the course of the fault-trace is marked almost its entire length by a swath of felled trees, true fault fissures being found at only two places. On the northern side of Bridge Creek Canyon there are typical cracks from 1 to 8 inches wide, and here also occurred a great landslide which buried the Loma Prieta Mill. The second place where fault fractures are found is on the ridge between Bridge and Aptos Creeks, where there are well-defined fissures up to 18 inches in width, trending S. 3° E., with a downthrow of the western (upper) side of from 2 to 6 feet, and a relative movement of the east side a few inches toward the south. The cracked zone is about 50 feet wide. Great slides on both sides of Aptos Creek have almost made a valley of the canyon for fully 0.75 mile. Following across the ridges and canyons, the discontinuous line of slides and sinks in upland marshy places marks the course of the fault-line down into the lowland.

B. Offset in fence at Morrell's ranch, above tunnel at Wright station. This particular displacement was not found in tunnel. *G. A. W.*  
*W. C. D.*

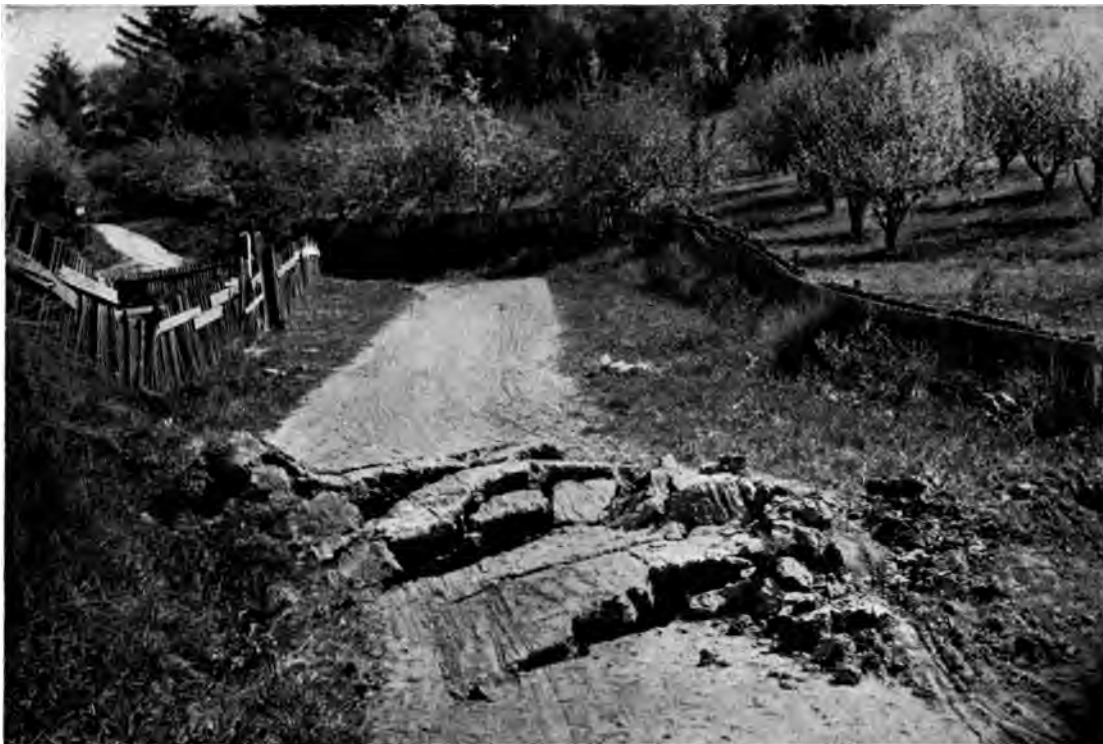
A. Offset in road near Wright. G. A. W.

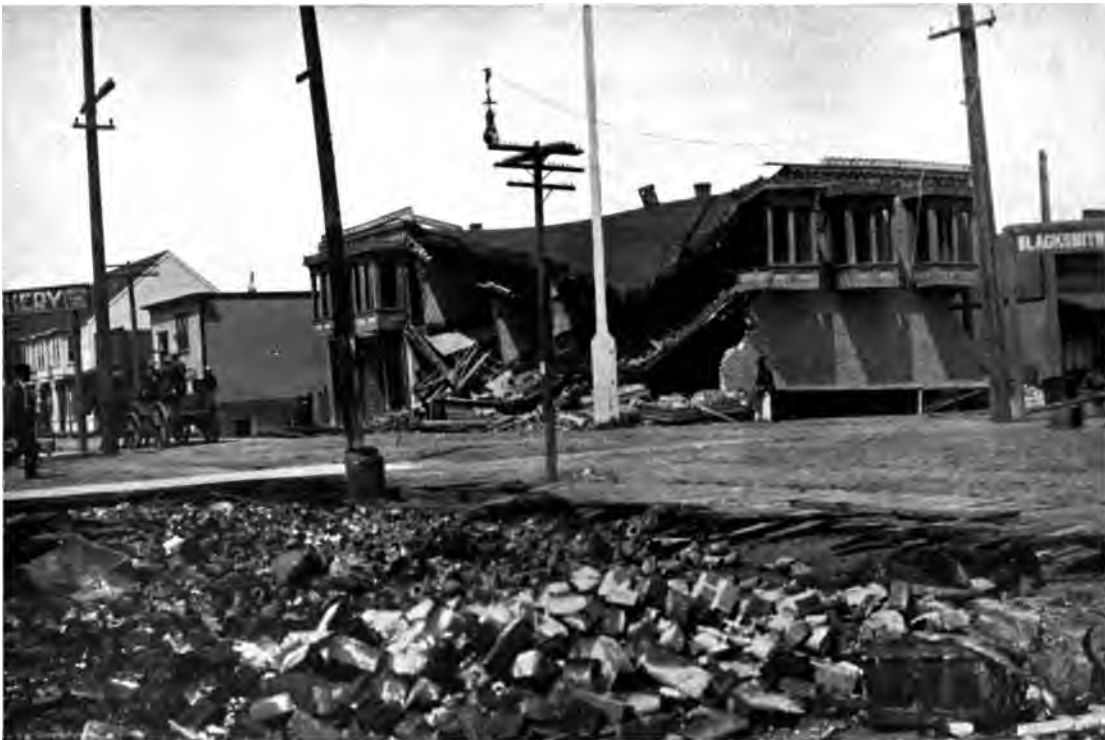
B. Wrecked buildings, Fort Bragg. Looking northwest.

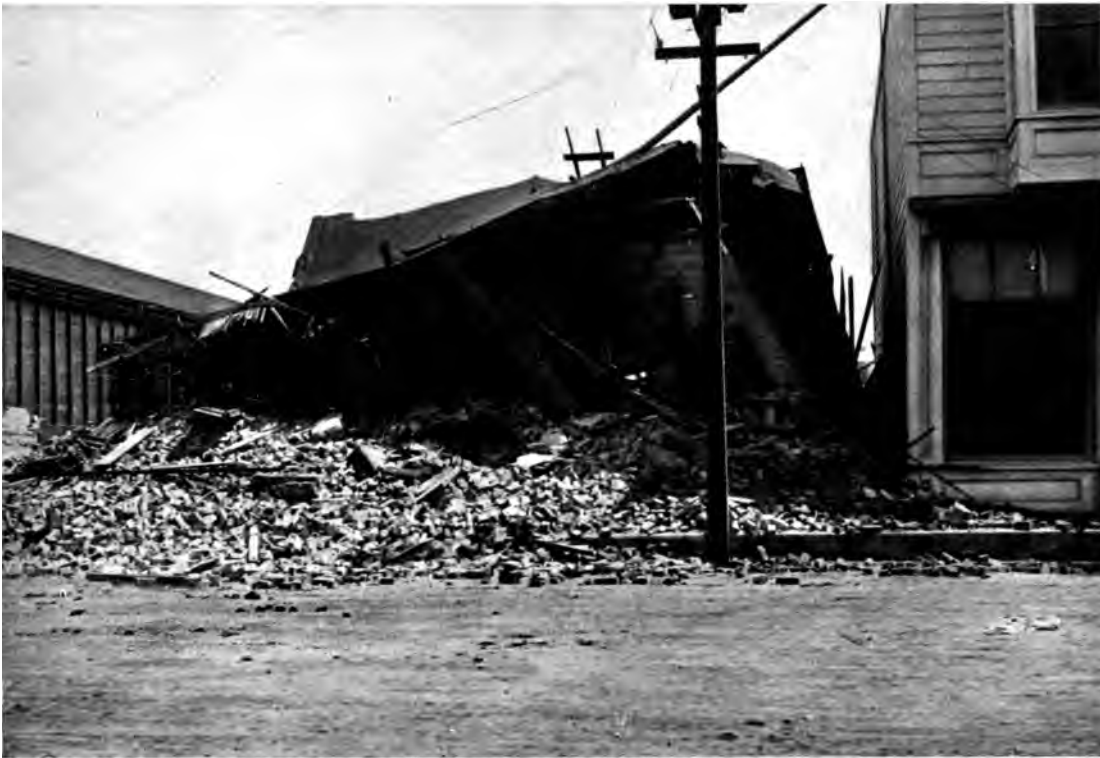
A. Odd Fellows' Hall, a 3-story brick building. Port Bragg. Looking east.

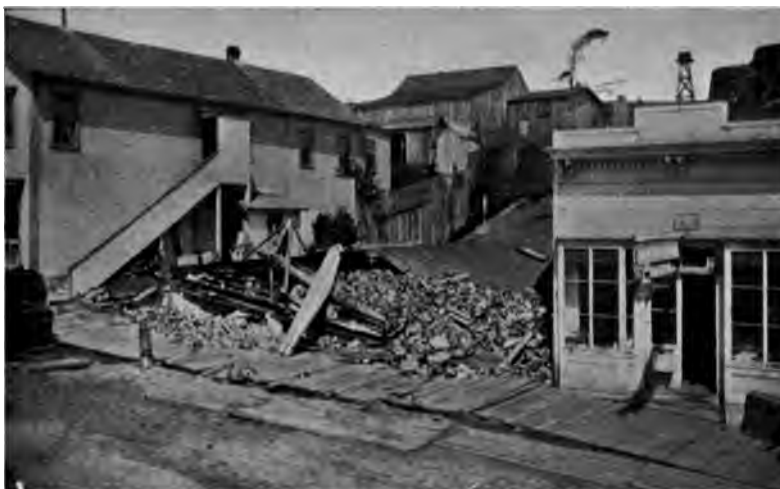
A. Point Arena. Brick house destroyed; wooden houses little affected. F. E. M.

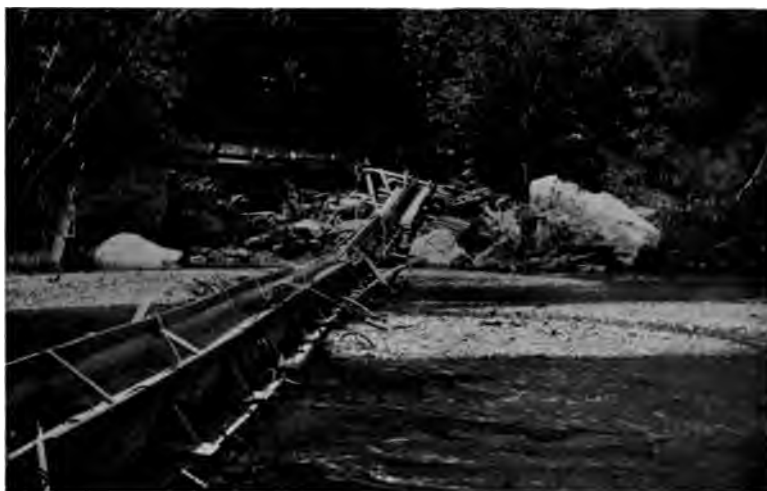
B. Wreck of suspended flume across Garcia River. Looking west. F. E. M.

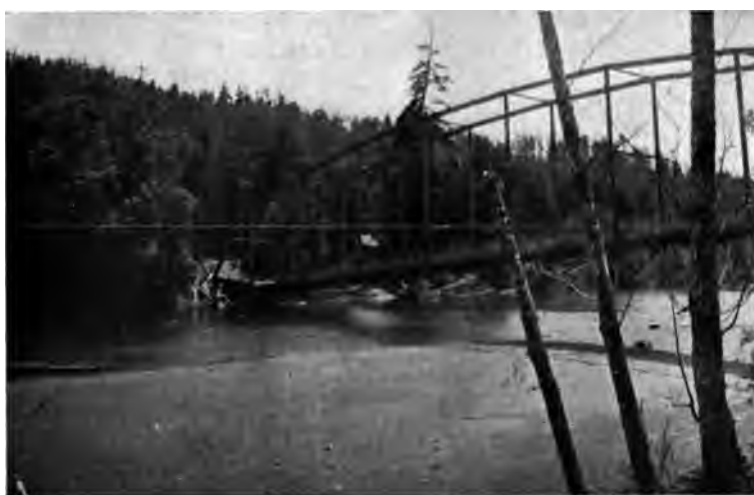
C. Collapsed wagon bridge over Gualala River. South end dropt 20 feet. F. E. M.

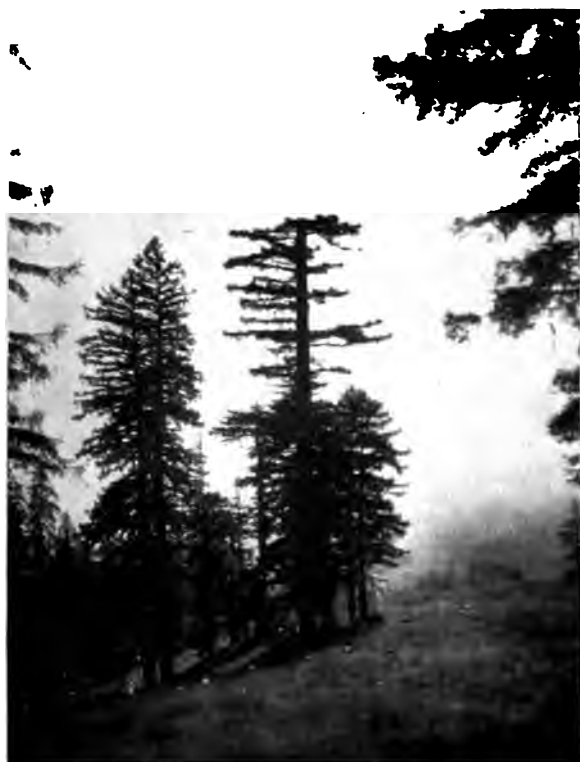
A. Sound redwood tree snapt off 42 feet from top. Near Fort Ross.  
F. E. M.

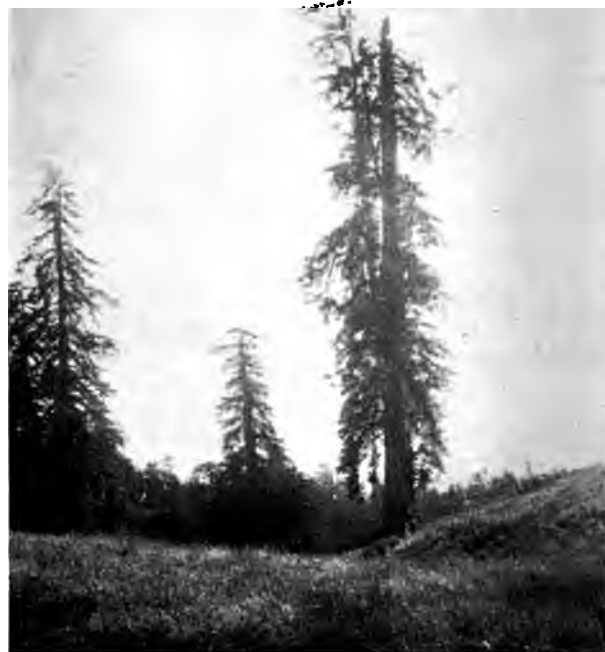
B. Redwood tree snapt off. Locality, 0.25 mile east of fault  
above Fort Ross. F. E. M.

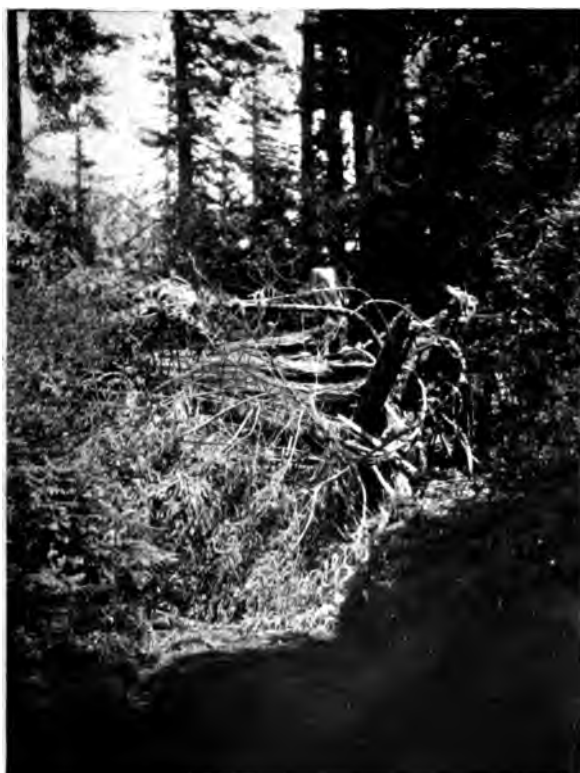
C. Uprooted tree, 8 feet in diameter, 187 feet long, about half mile west  
of Garcia River, on road to Garcia Mill. Tree sound. F. E. M.

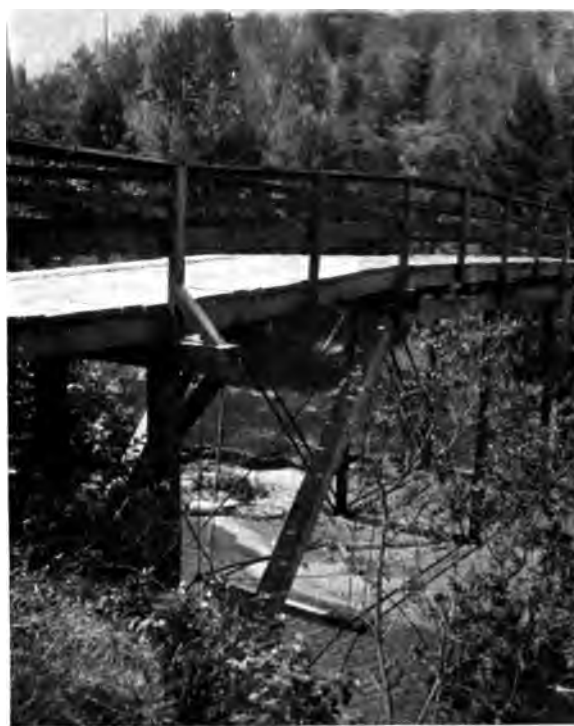
D. Bridge over South Fork, Gualala River, 3 miles east of Stewart's Point, look-  
ing north. Bridge floor and panels bent; tension rods buckled. F. E. M.

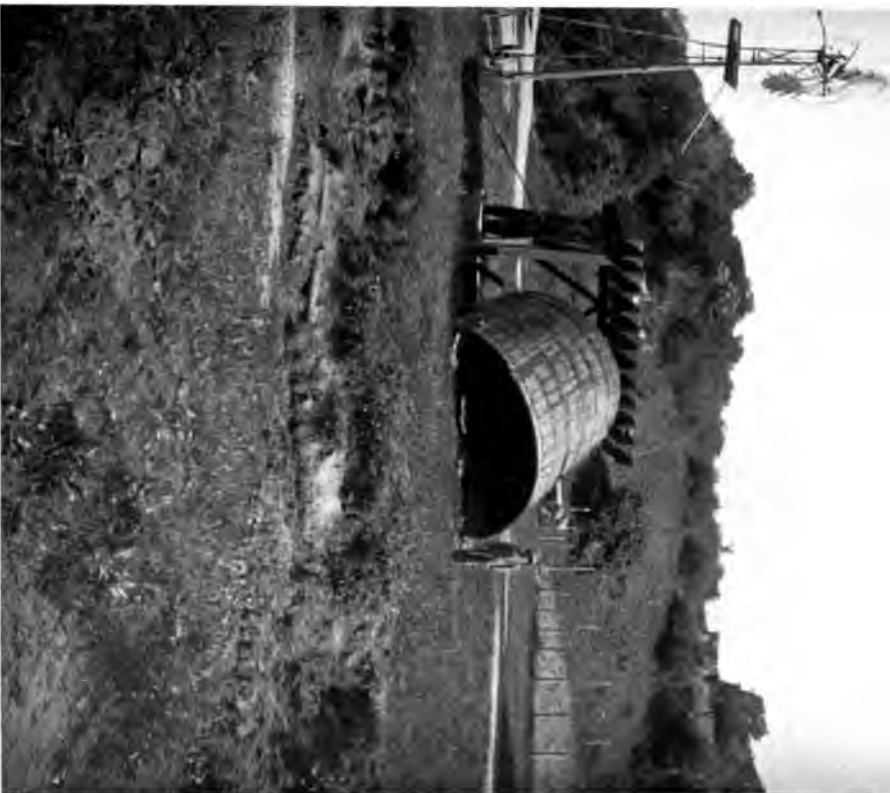
B. Wrecked water-tank, near Inverness. G. K. G.

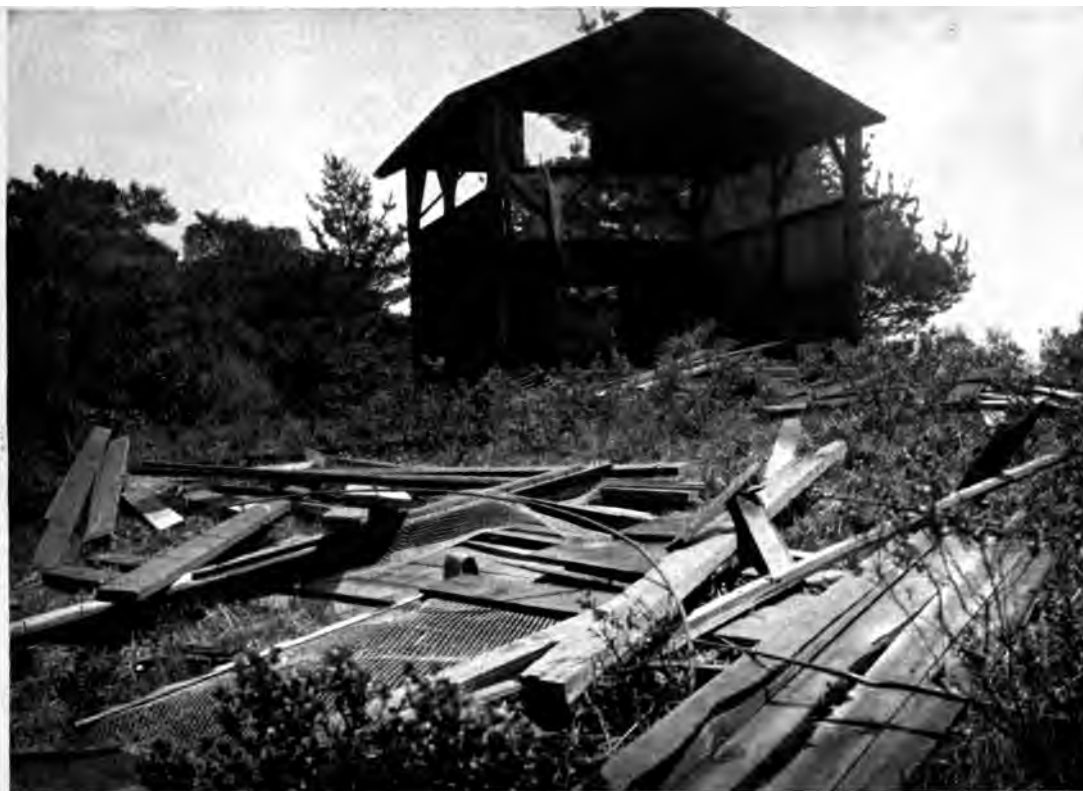
A. Ruin of Inverness reservoir, a circular tank which before earthquake stood in shed. Parts of shed also lie in foreground, about 50 feet from original position. G. K. G.

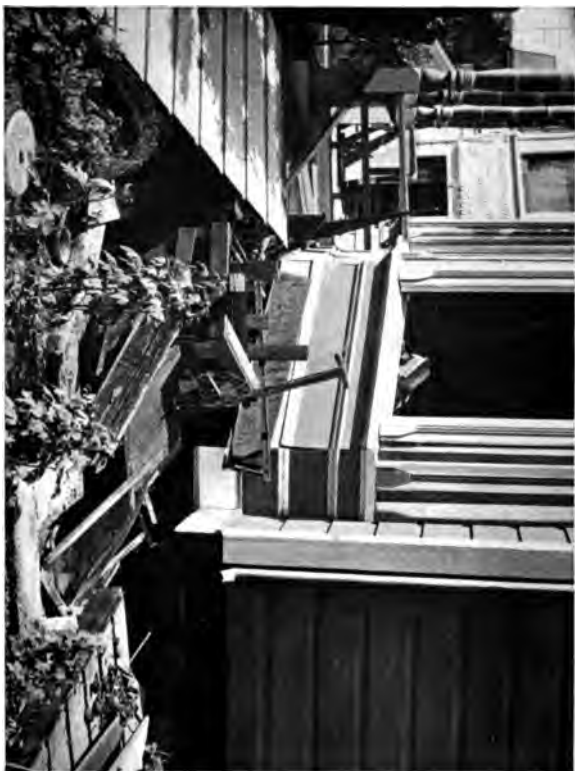
A. House moved 7 feet by collapse of underpinning, Santa Rosa. R. S. H.

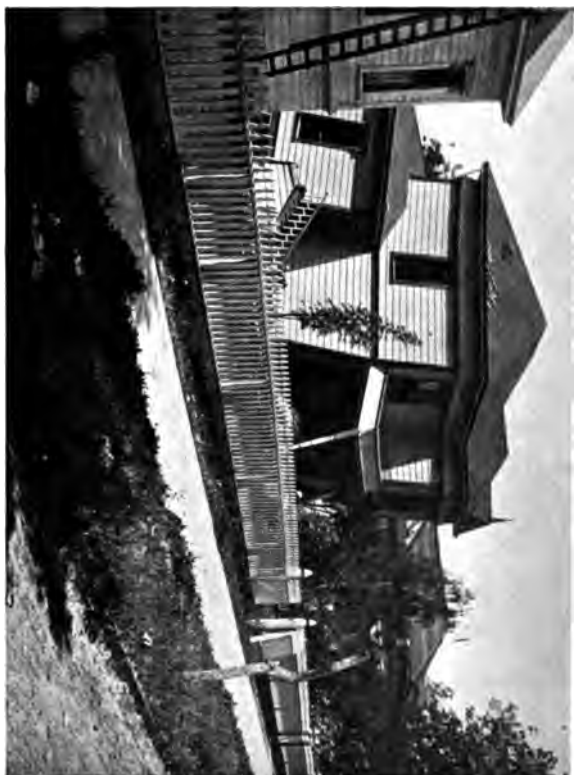
B. House lurched to north, Santa Rosa. R. S. H.

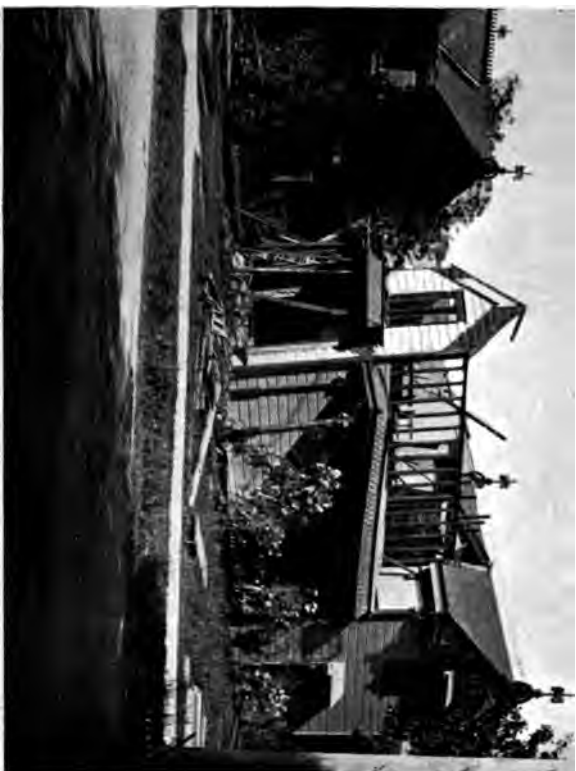
C. Wrecked dwelling, Santa Rosa. R. S. H.

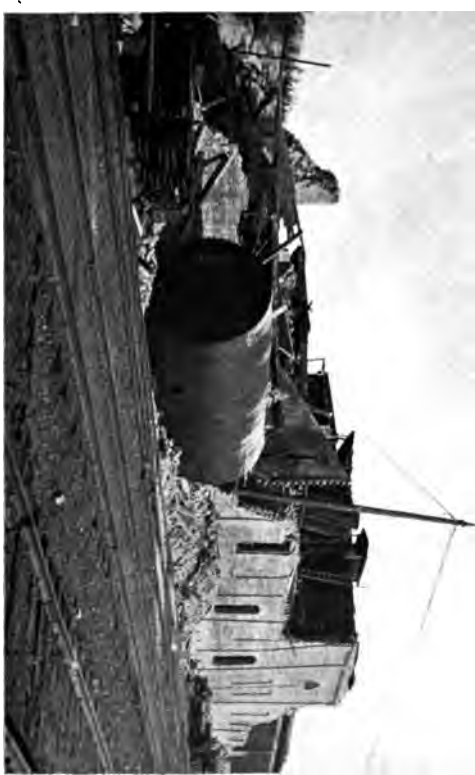
D. Wreck of brick structure, Santa Rosa. R. S. H.

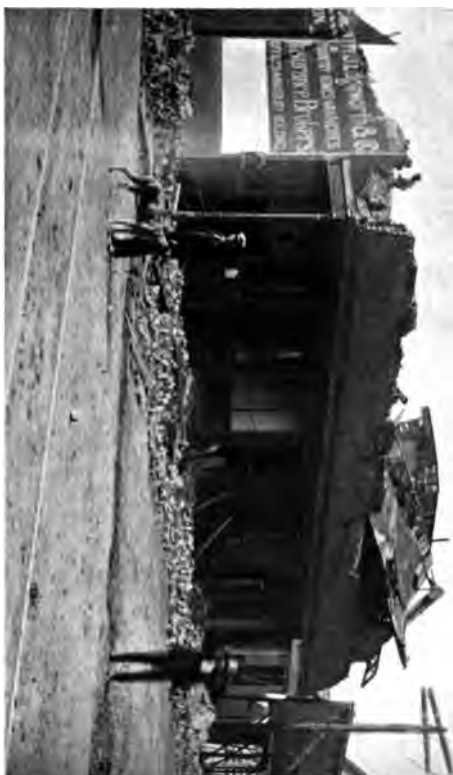
B. Wrecked buildings, Sebastopol. R. S. H.

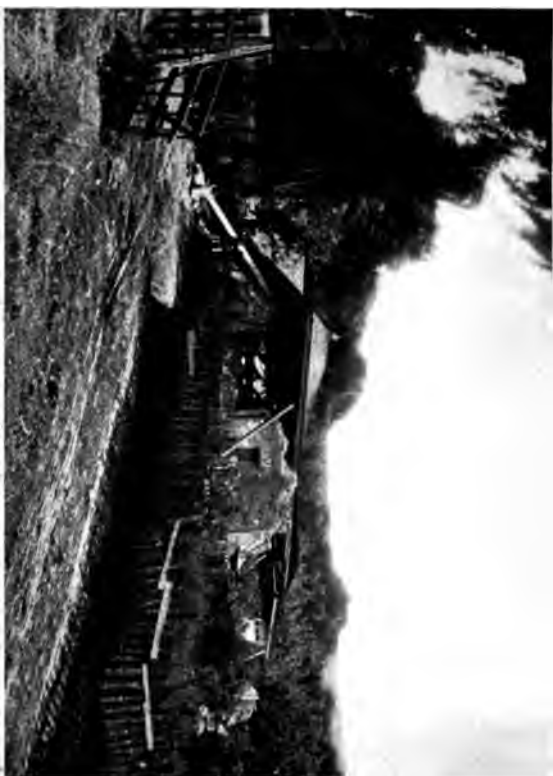
C. Stone house 1.5 miles southeast of Tomales, where two people were killed at time of earthquake. R. S. H.

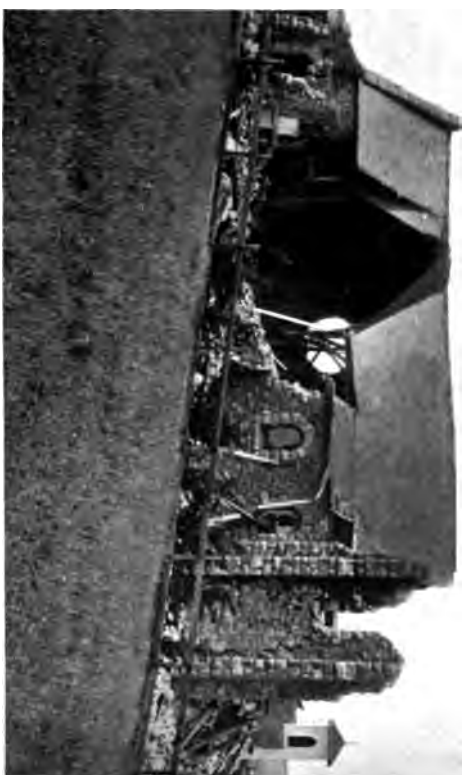
D. Wrecked church, Tomales. R. S. H.

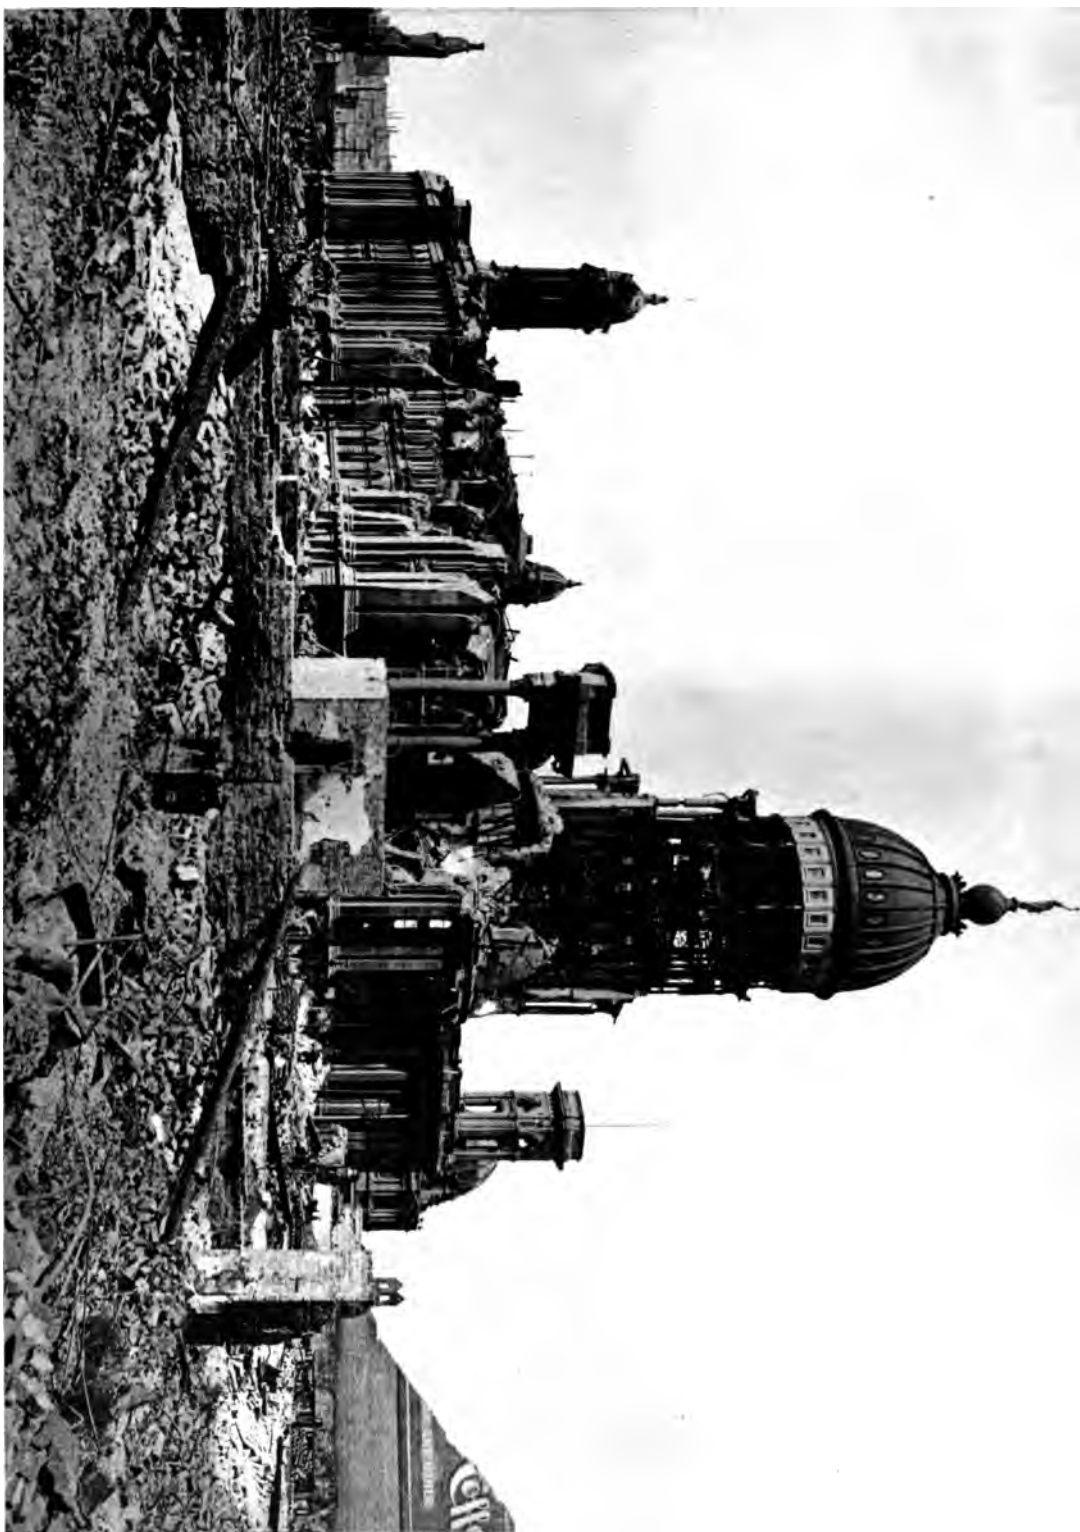
City Hall, San Francisco.

Near the City Hall there was a small locality conspicuous for the damage produced. The City Hall itself made a picturesque ruin (plates 82 and 83A), as all the world knows, but the character of the construction was probably a large factor in its destruction. Nevertheless ugly cracks in other buildings near by indicated intensity somewhat higher than was common in the valley district as a whole.

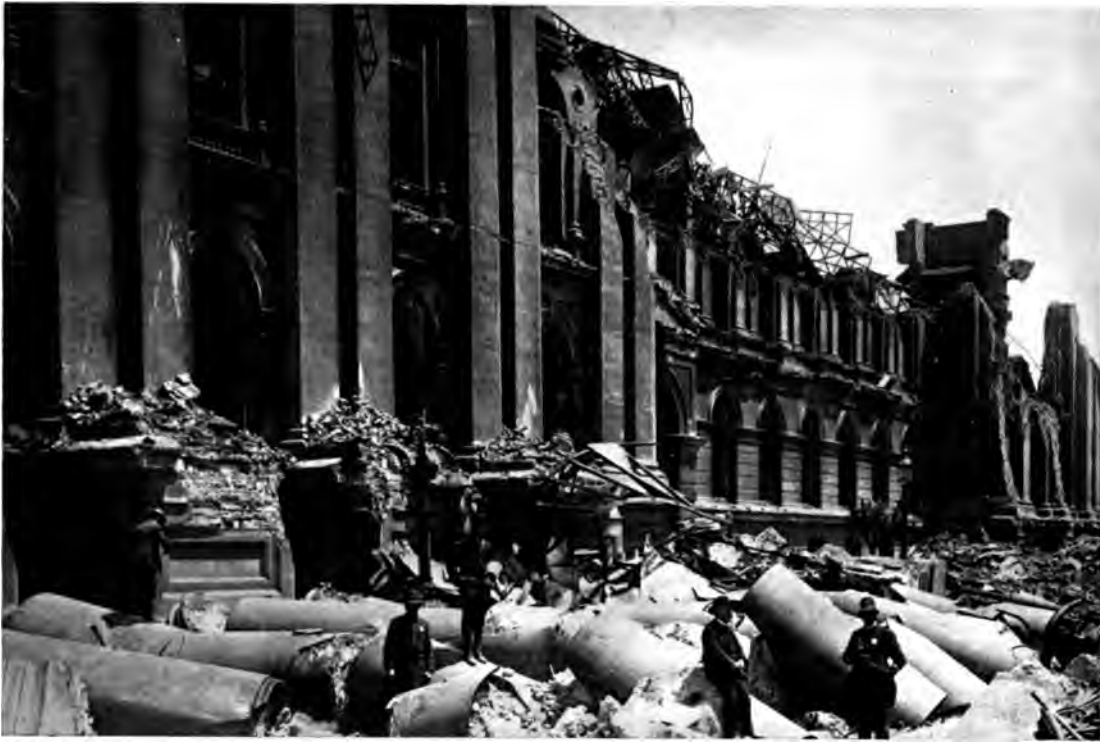
A. A near view of the wreck at the City Hall, San Francisco.

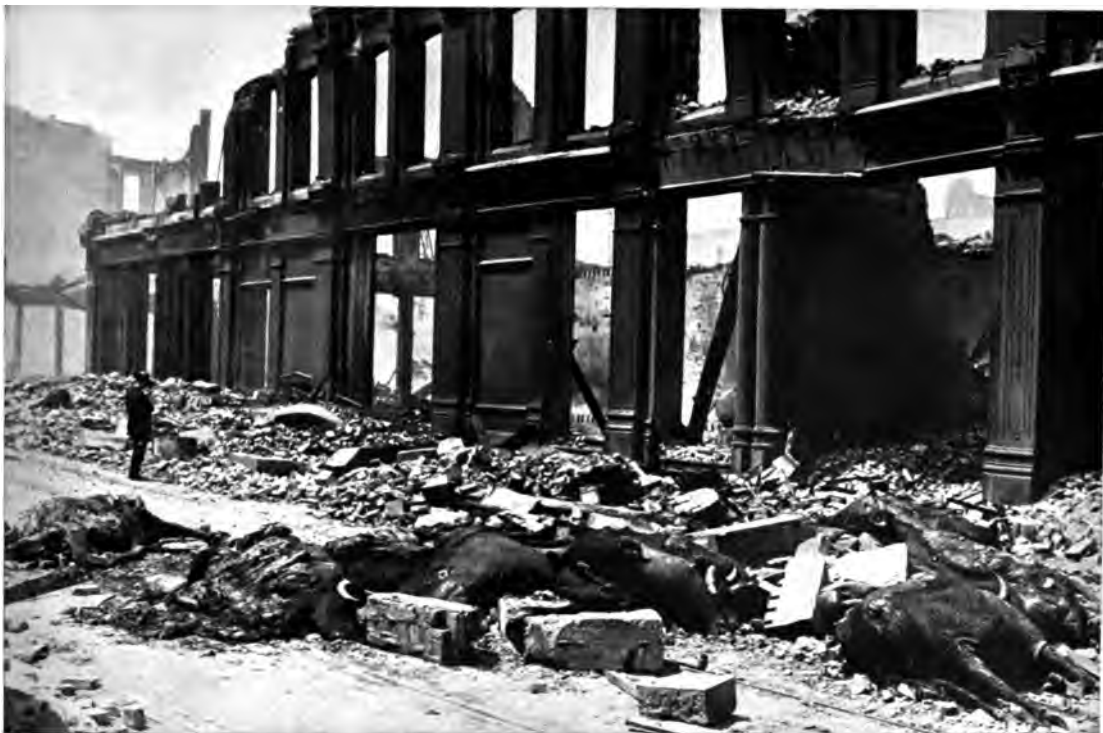
B. Cattle killed by falling masonry at time of earthquake, San Francisco.

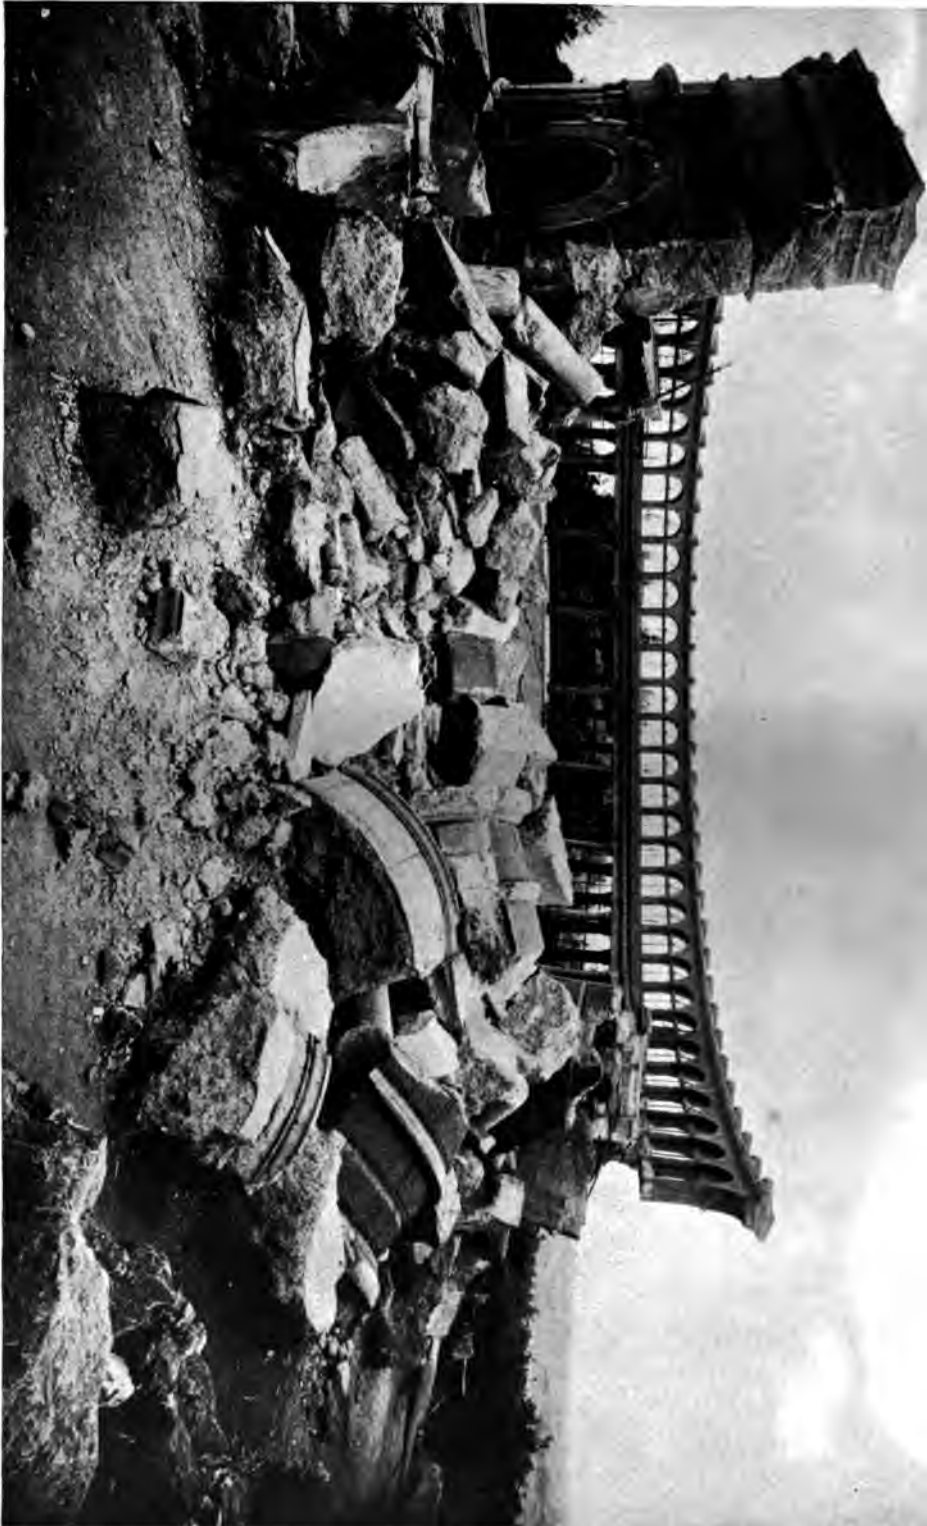
Observatory, Strawberry Hill, Golden Gate Park, San Francisco. W. E. Worden, Photo.

Strawberry Hill, in Golden Gate Park, is a chert knob rising abruptly in the sand wastes. Its summit had been leveled, but it is not known whether this was done by cutting off the top and filling out the upper slopes, or by filling alone. The altitude given for the present hill is the same as that given in the earliest accurate surveys. Much artificial stone work, and a circular concrete observatory building 2 stories high, had been erected upon the leveled hilltop. This building was of weak design, having a row of columns, with windows between, which rested upon a foundation wall 3 feet high and supported a heavy second-story balcony. The construction itself was probably good, but the observatory was utterly ruined by the shock. (Plates 84 and 85.) The entire lower story was sheared out of position, and part of the balcony fell. The cement floor showed numerous cracks arranged in a roughly concentric way.

The whole periphery of the hilltop was broken into a series of concentric blocks or steps, and the outer ones moved down the hill from 2 to 3 feet. The artificial stone work was badly cracked and dislodged. These phenomena indicated that the material used in grading the upper slopes had settled somewhat, with consequent rupture of the surface and wrecking of the building. No other explanation can be urged for such striking damage on this hill, in view of the small damage produced on other rock summits in the city.

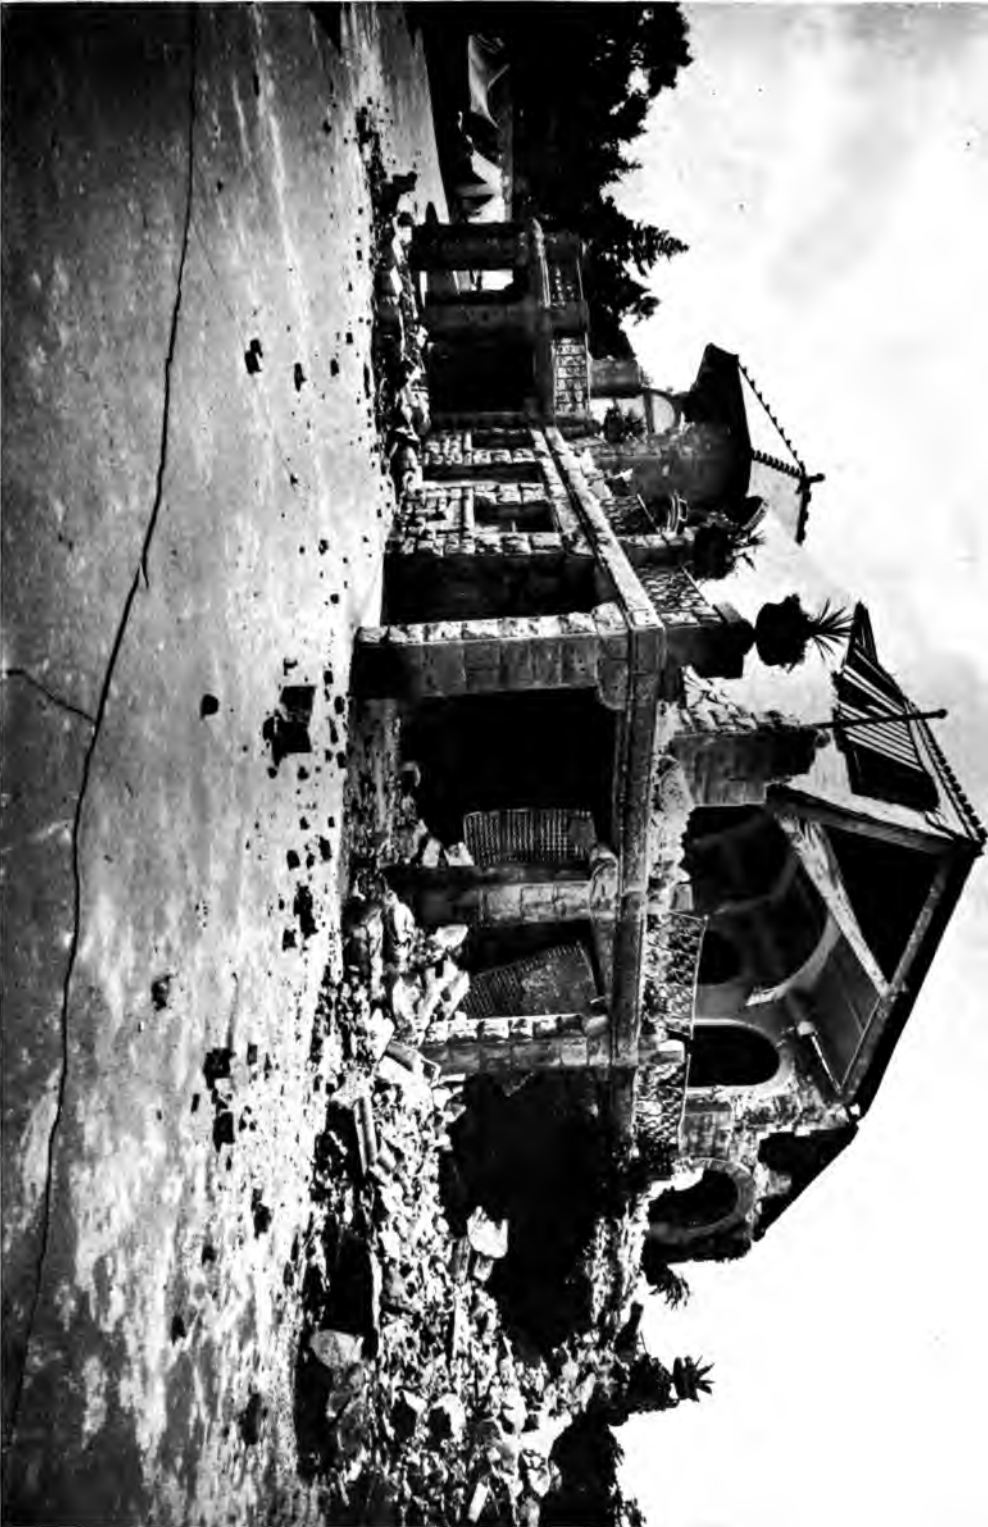
Observatory, Strawberry Hill, Golden Gate Park, San Francisco. W. E. Worden, Photo.

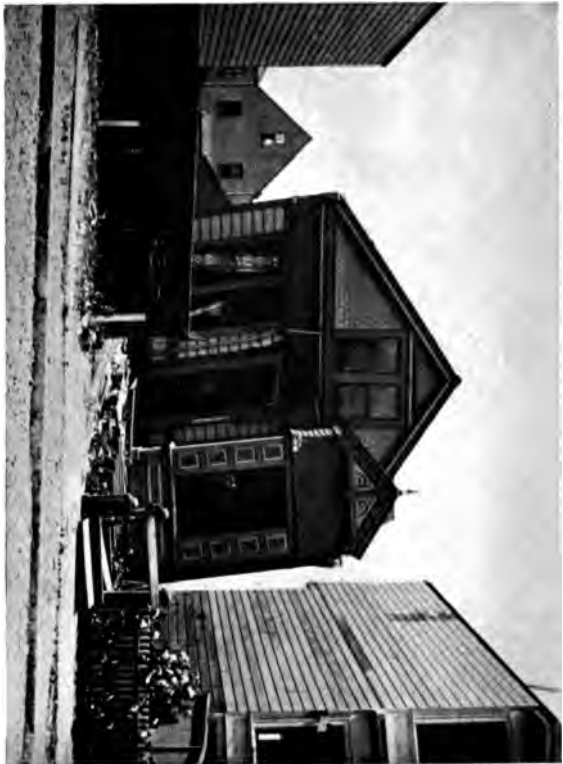
A. Frame building on west side of Eleventh Avenue, just south of California Street, San Francisco. A weak structure, built on sand. H. O. W.

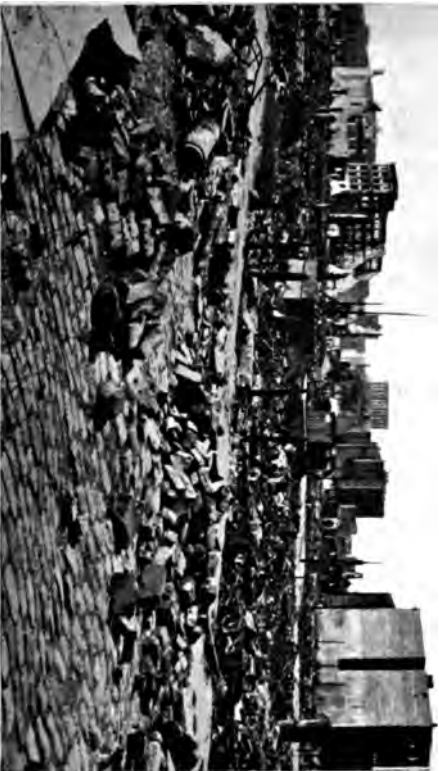
C. Russ Street, between Folsom and Howard Streets, San Francisco. Paving blocks forced up into sharp arches and dislodged by compression. H. O. W.

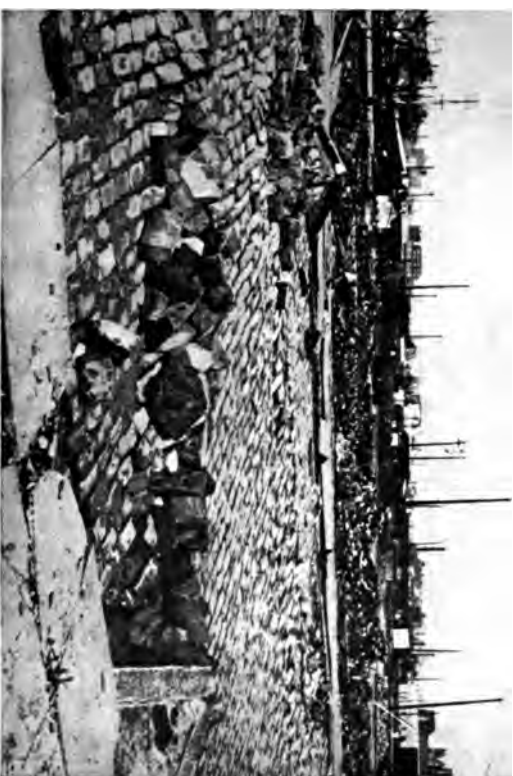
D. Moss Street, between Folsom and Howard Streets, San Francisco. Paving blocks arched by compression along sinuous crest, curbing thrown into an inverted V. H. O. W.

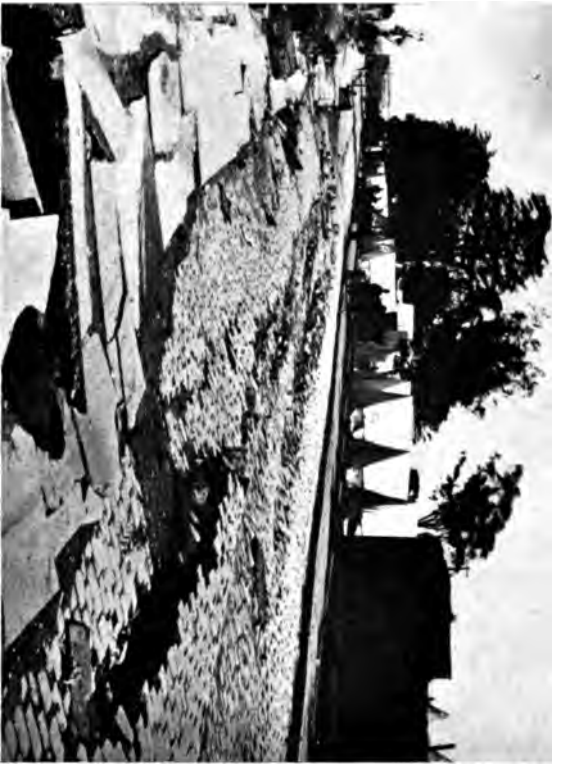
**A.** Columbia Street, just south of Polson Street, San Francisco. Slumping, depression, and narrowing of block pavement. H. O. W.

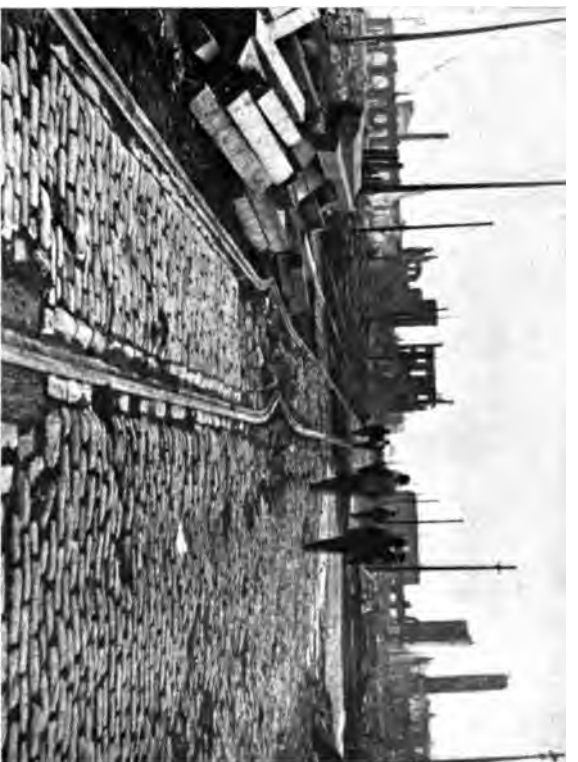
**B.** Bryant Street, near Fourth Street, San Francisco. Flexure of heavily ballasted car tracks in block pavement; an effect of sharp compression. H. O. W.

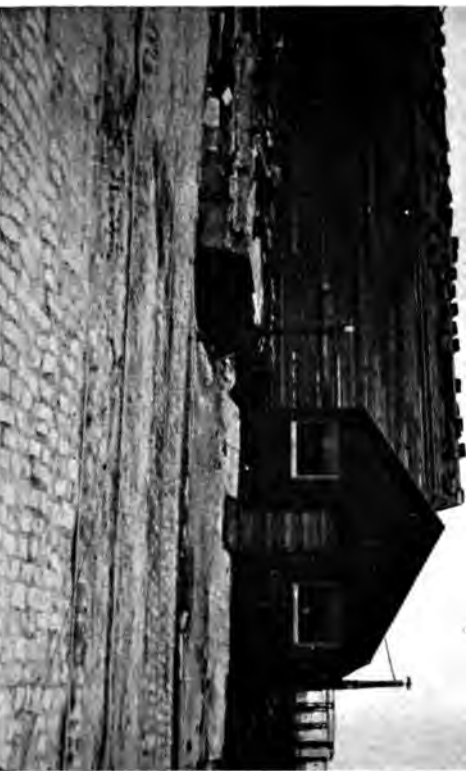
**C.** Sixth Street, near Howard. Once occupied by marsh. Street drops nearly 3 feet. Sidewalk held up by piling foundation of a building. H. O. W.

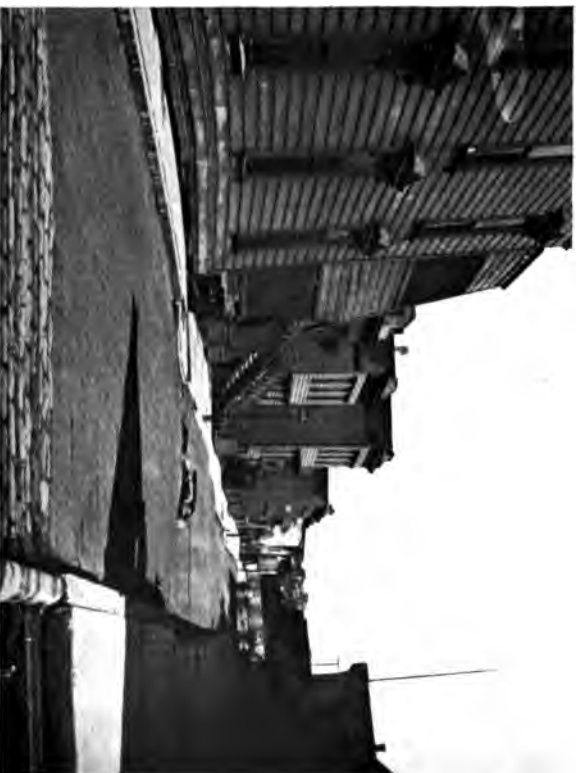
**D.** Looking along Dore Street, from Bryant toward Brannan. Undulating and fractured condition of pavement due to earthquake. Houses thrown off their underpinning and pitched out of the vertical. H. O. W.

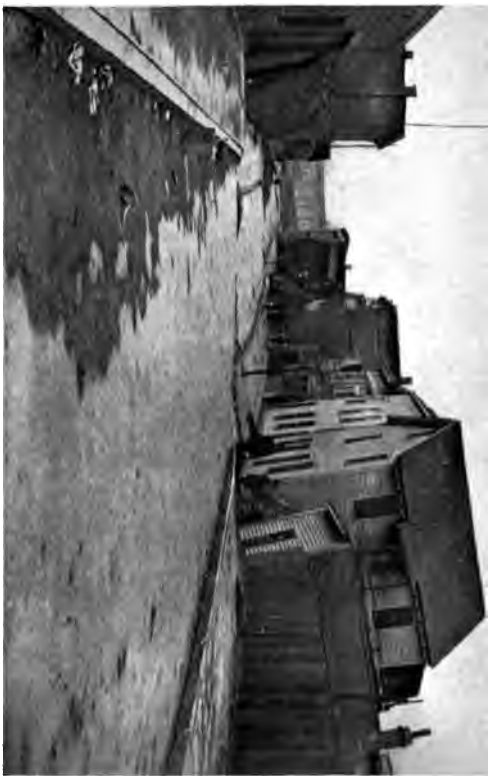
A. Looking along Dore Street from Brannan toward Bryant. Larger undulations near Brannan. Dore Street is on site of an arm of Mission Creek. H. O. W.

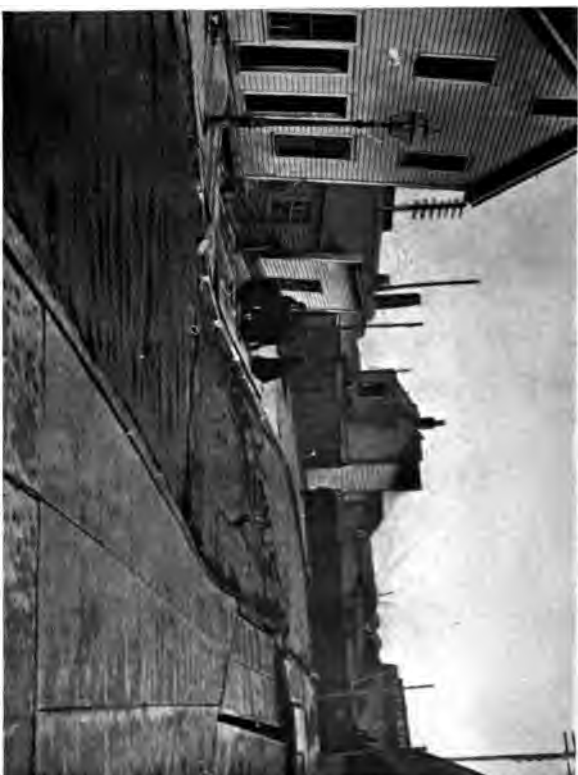
B. Dore Street, near Brannan. Vertical difference between crest and trough of undulations, 5 feet. H. O. W.

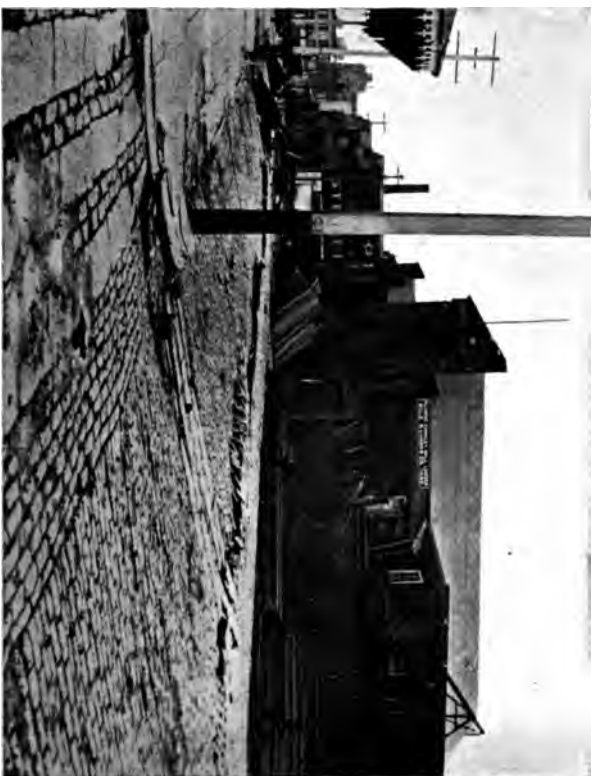
C. Eighteenth Street, just east of Shotwell. Plastering and depression of pavement. H. O. W.
